## **GOM Diving Safety Work Group**

## **JAN 2014**

## **Underwater Burning**

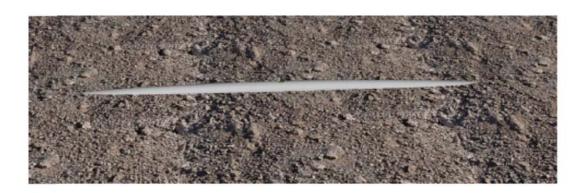
## Venting Pipelines with Overbends

Possible gas pocket at peak of overbend

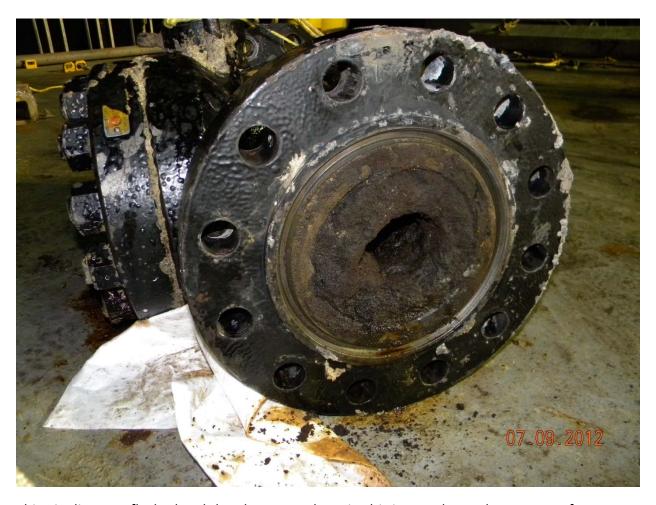
This pipeline was flushed and the plan was to burn it, this image shows the amount of extremely flammable residue that had built up over the years of service. Thankfully the decision was made to use alternative cutting methods.

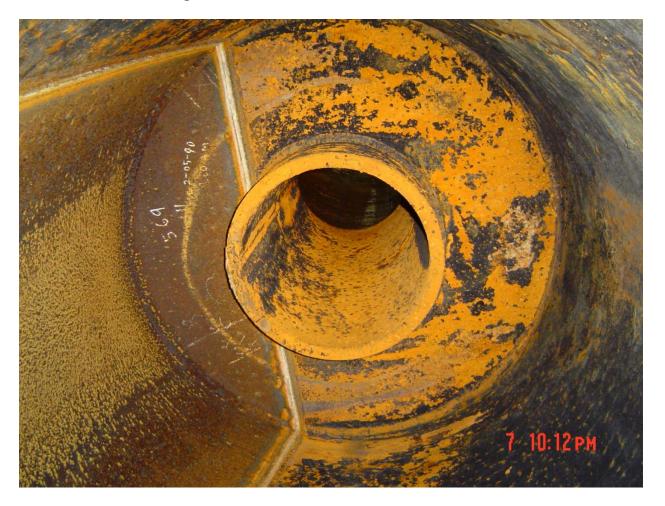
## Internal Stiffener Rings Inside of Members

Internal stiffener rings found inside of VD and skid beam members on this platform. If a member is at an angle gas could be trapped on the topside of the pipe even though it appears to be open ended. This member was cut with a diamond wire saw and gas of some sort did escape. Burning below one of these stiffeners would be a bad day.
